RE: Baruch College - Site "B"
Contract #16 - GC #2
Epoxy Terrazzo - Uplift/Debonding

PRELIMINARY SITE INVESTIGATION REPORT

Client:	TDX Construction Corp.	Lab #:	Pending
Project:	Baruch College - Site B	Report #:	ML-01
Address:	55 Lexington Avenue	Field Visit Date:	03/04/03
	New York, New York	Report Date:	03/05/03
Construction Type:	Terrazzo flooring system on concrete slab	Petrographer:	J. Walsh
		Page 1 of 10

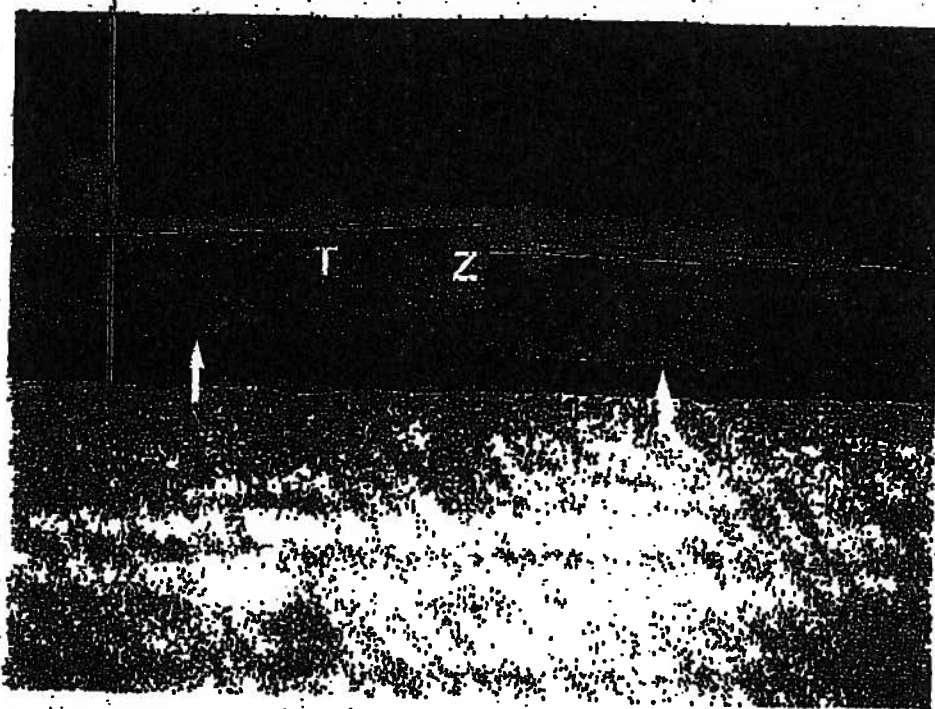
- 1) The placement history is suggested by observed field relationships. A lightweight slab on deck was placed. A surface consistent with a trowel finish is detected (i.e.; a smooth surface containing all cream and no raised fine aggregate). In some locations (1G and 1N) a deep scarification of the hardened slab was performed. In others (2E), some fine scouring is evident. In other locations (B1, 2W, 7, and 12) one or more layers of self-levelling compound were placed over the structural slab. A thin layer of gray epoxy membrane was placed. Zinc strip adhesive was placed before the epoxy membrane solidified. This is indicated by the indentation of the membrane by the adhesive (most clearly detected at probes 2E and 12). The zinc strips were embedded while the adhesive was uncured (also indicated by indentation). It would appear that the membrane, adhesive, and strips were all installed in quick succession as a single procedure as no other disruption of the membrane is detected. The terrazzo system was placed after all other components were hardened (not necessarily cured) and well compacted against the zinc strips. The hardened terrazzo system was ground and polished.

- 6) At each probe, the failure occurs between the epoxy membrane and the substrate. The debonding occurred cleanly without pulling out any portion of the substrate and rarely leaving any residue of the membrane behind. This condition exists whether the substrate is concrete slab or self-levelling flooring. It is also notable that no residue of the epoxy membrane is found within any negative relief areas of the substrate. Even where the

substrate is deeply scarified (1G and 1N), no relic of the epoxy membrane remains in the grooves.

Figure 1: Probe location 1N. The arrows indicate the debonding site which always occurs between the epoxy membrane and the substrate. The epoxy membrane is too thin to see in a macroscopic photo cross section. (C = concrete, T = terrazzo, Z = zinc strip).

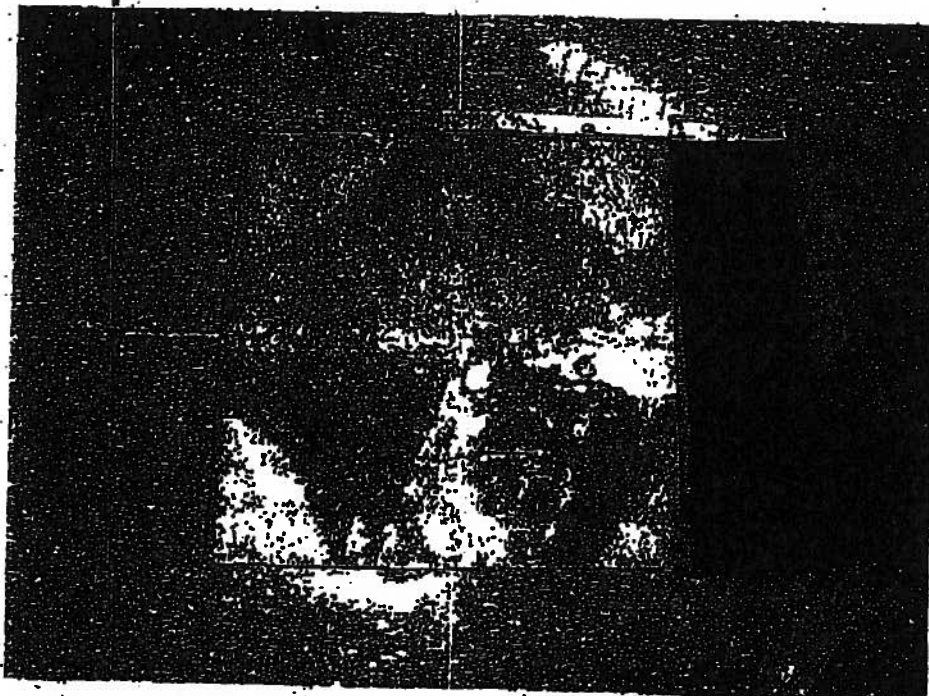
- 8) Probe 2W exposes a section centered on a corner of four terrazzo segments. The original debonding (as opposed to that created by the sample removal) is clearly defined as a rounded cross. This indicates a regular ovate pattern of failure.

Figure 2: Probe location 2W. The location intersects the corners of four terrazzo segments. The dark rounded cross reflects where the epoxy debonded cleanly from the substrate. The lighter areas reflect "rip-ups" during sampling. The debonding pattern is consistent with that related to shrinkage.

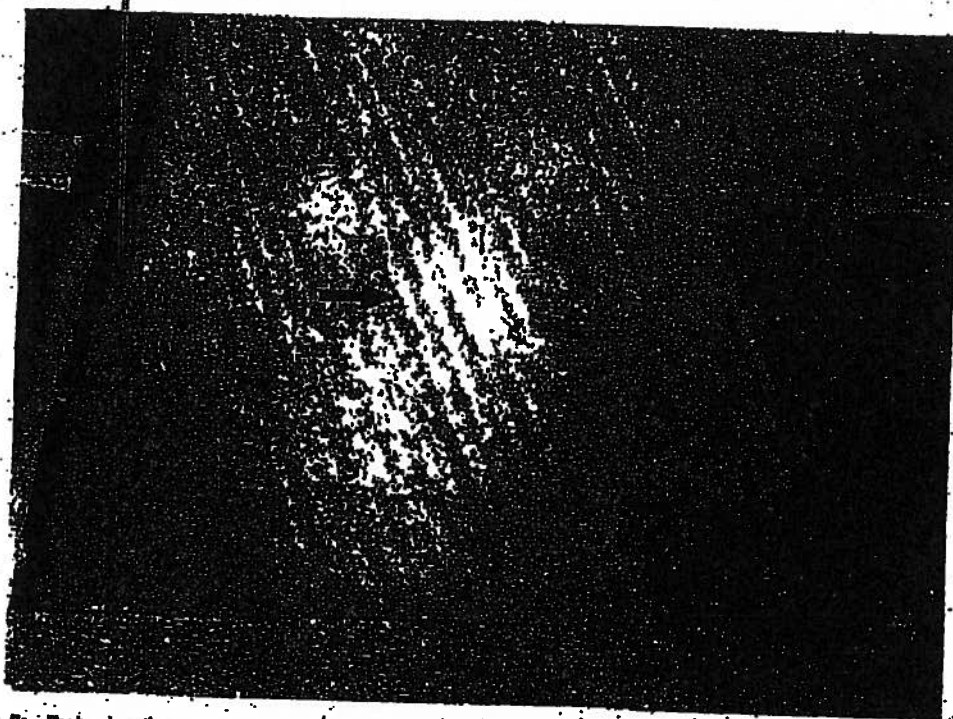
There appears to be some evidence of residues below the epoxy membrane and this is an area for further investigation. Incomplete cleaning of the substrate may be responsible for a weak epoxy bond. This seems likely particularly where the concrete slab is scarified and the membrane has not even adhered to the rough grooves of the preparation. In terms of materials, there does not appear to be any deviations from the manufacturer's recommendations. It may be more difficult to determine whether or not a curing agent had been applied to the concrete.

Figure 3: Probe location 1G. The substrate here is a scarified concrete slab and the arrow indicates one of the scarification grooves. No epoxy membrane is adherent along either the smooth troweled surface or the rugged grooves.

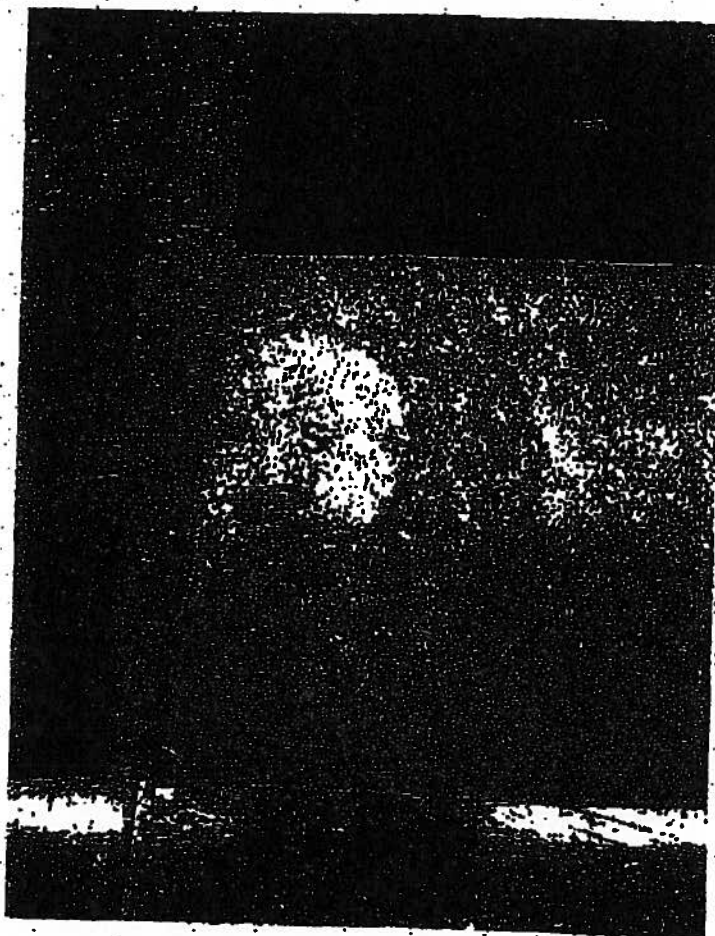
Figure 4: Probe location 12. No epoxy membrane is adherent to either the self-leveling compound (S) or the concrete substrate (C).

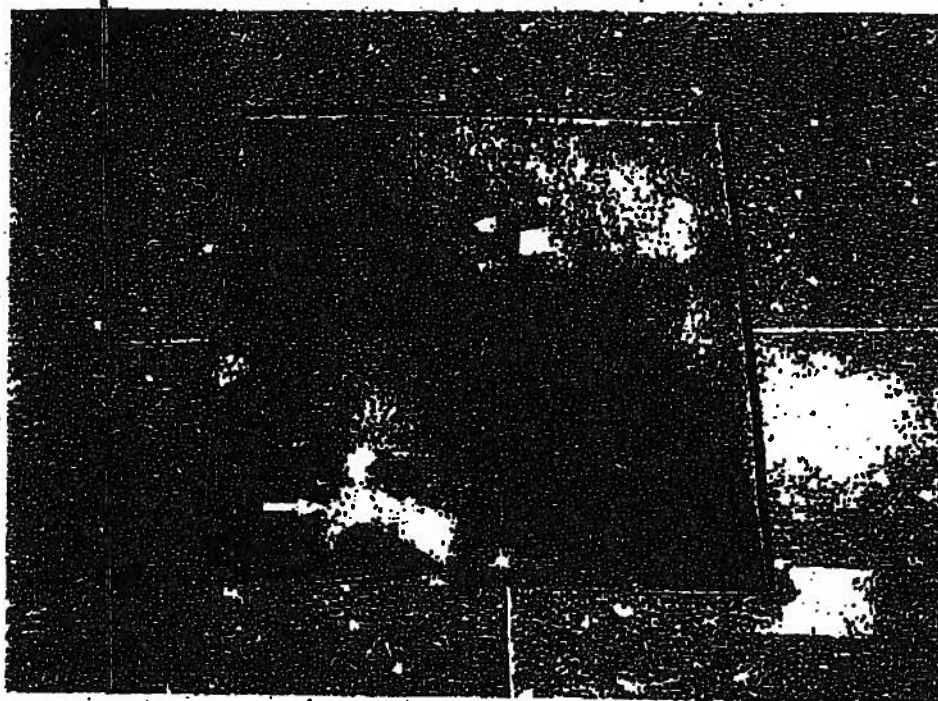
- 11) Some indication of failure between the slab and self-leveling flooring bond is noted. This is evidenced by clean separations at probe locations 7 and 12. Probe B-1 exposes a four corner contact. Sounding of the substrate revealed a debonding of the Conflow only below one corner of the four terrazzo segments. Samples of the debonded Conflow were recovered freshly from the substrate.

Figure 6: Probe location B1. The epoxy membrane is completely debonded from the smooth self-leveling compound surface. In the lower left quadrant (arrow), the self-leveling compound is clearly debonded from the concrete substrate. Sounding indicates that the debonding is present nearly everywhere below that one corner.
